# INSTALLATION OF CROSSING LIGHTS ON CALDER NORTHERN UNION MILLS LAYOUT.

By Roy Harris.

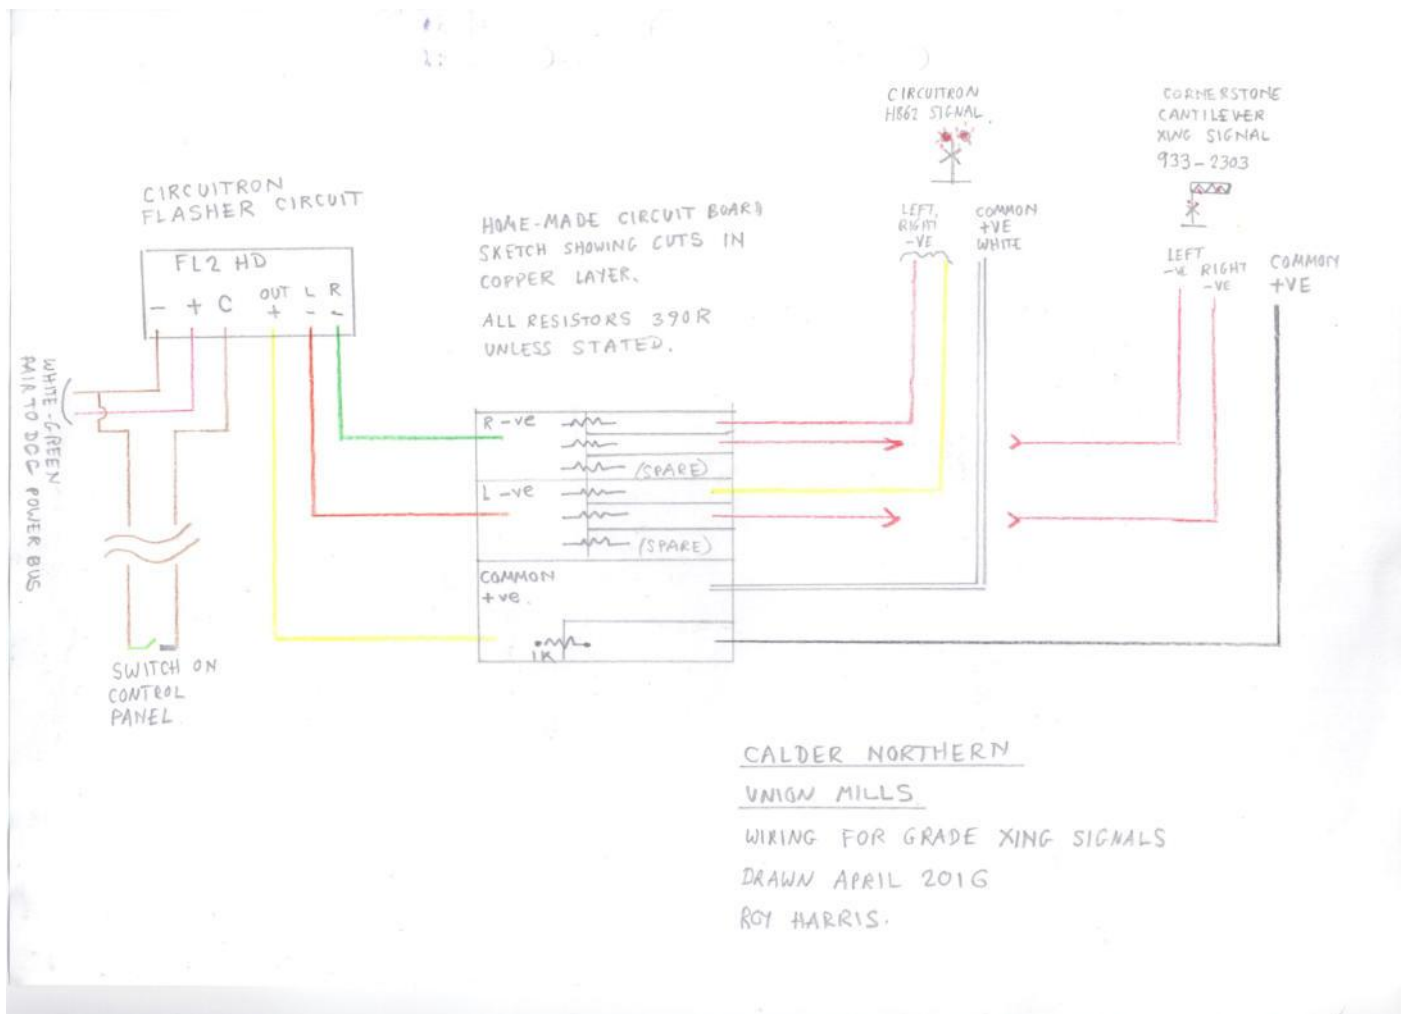
There is provision to use it with a Circuitron detection unit, but in this case an on/off switch was deemed acceptable fitted as shown in the diagram.

In order to join all the leads together and hold the current-limiting resistors I made a small circuit board from a plain piece of copper-clad board. Pads were formed by scribing and cutting the copper as shown by solid lines. Then check each pad is isolated from its neighbour. Holes were then drilled to accept the resistor leads and these were soldered into place together with the leads from the signals.

- A Circuitron H862. A traditional pair of flashing lights (LEDs) on a pole with "Railroad X Crossing" signs below. The spare unit I was loaned to experiment on had five wires: 2 yellow, 2 red and 1 white. I followed the convention that red would be positive...WRONG! That led to a damaged LED which had to be replaced. In doing so I got the soldering iron too close to the adjacent LED and that had to be replaced. You see where this is going? In fact the white is common positive while yellow and red are negative to the individual LEDs. It turned out that the unit installed on the layout only had lights on one side, so there was one lead in each of the 3 colours. This explains the spare resistors shown in the diagram.
- A Cornerstone Cantilever crossing signal 933-2303. This had 2 red wires which were negative LED terminals while the black was common positive.

To operate these I was supplied with a Circuitron FL2HD flasher unit. Quite a versatile unit in that it has quite a wide range of input voltages, either AC or DC. In this case power was taken from the main DCC bus. I was fortunate that there was a joint in the bus adjacent to the location of the FL2HD facilitating quick fitting of the power leads.

LEDs require current limiting resistors. The instructions seemed a bit confusing and it seems overkill to have them on both positive and negative leads to the Cornerstone lights. Better safe than sorry.
